International Journal of Advanced Research in Arts, Science, Engineering & Management

Re-design of Geometrics for Hubli-Dharwad Bypass km 417-419 (Bangalore-Pune) Accident zone

ABSTRACT: The aim of this project is to conduct a study of the geometrics of the Study Zone and also a study on vehicular behavior /road user (driver) behavior and work out a solution to reduce the number of accidents and thus save lives and property of the nation.

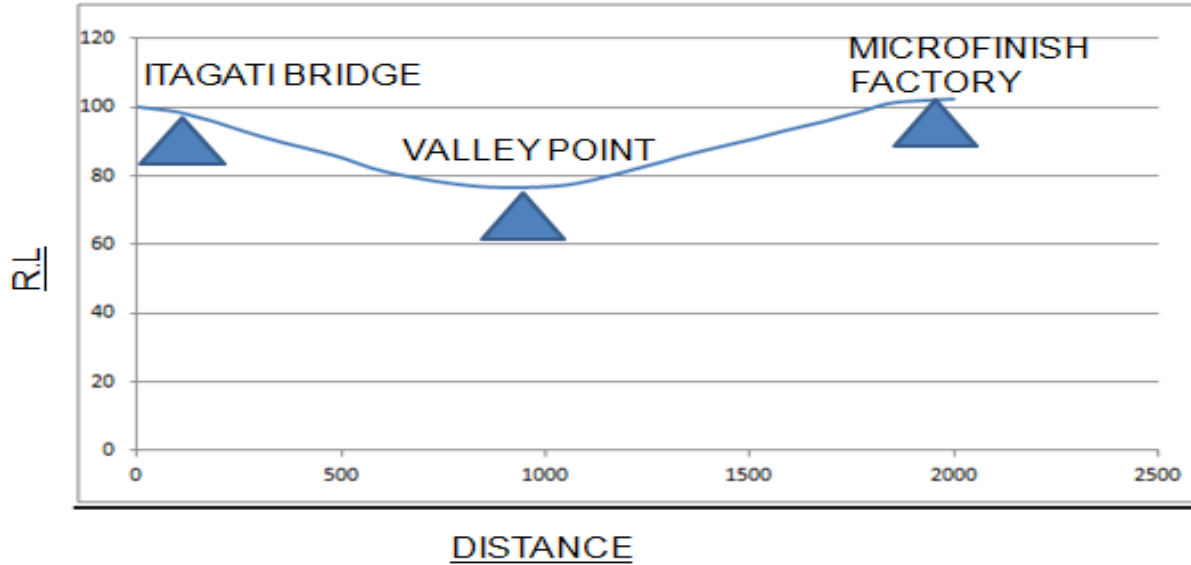
LONGITUDINAL PROFILE OF STUDY ZONE

- i) RL AT ITAGATI BRIDGE IS 97.84 M
- ii) RL AT VALLEY POINT IS 76.56 M
- iii) RL AT MICROFINISH FACTORY IS 101.27 M

This particular stretch has a sharp horizontal curve along with a valley curve formed by two steep slopes. Accidents which have taken place in this stretch have been regularly reported in newspaper, many of them involving loss of human life

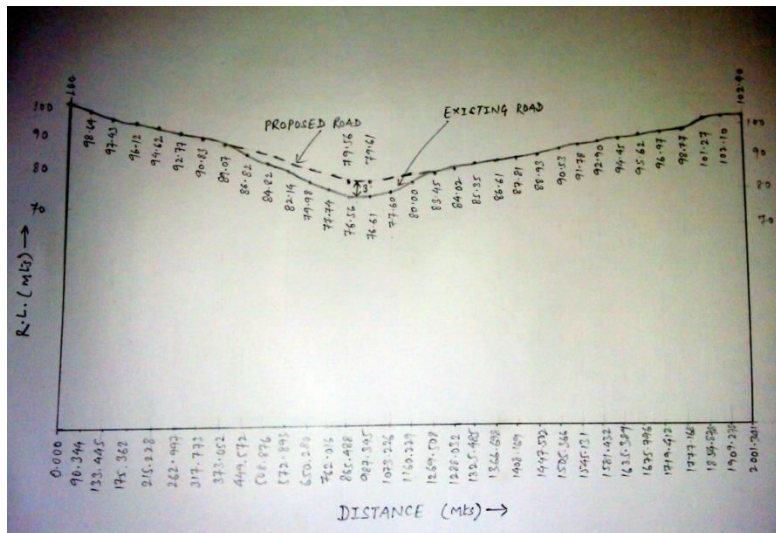
Suggested corrective measures:

1. Gradient on the microfinish factory side to be reduced to avoid congestion of traffic.
2. To raise the valley point reduced level by 3.00 mts by constructing a bridge/embankment.
